# GELDAKER RIVERBANK STABILIZATION RAMSEY, MN

## Project Summary

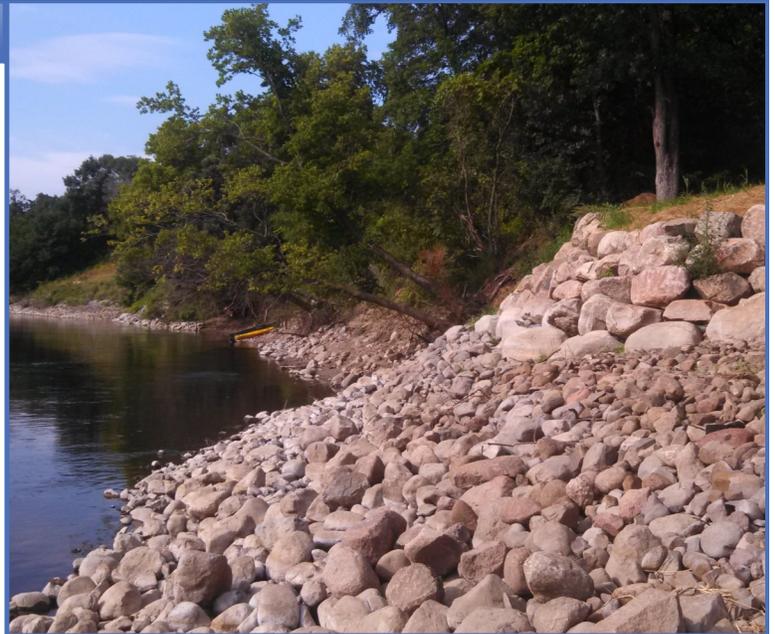
Completed project in the summer of 2014.

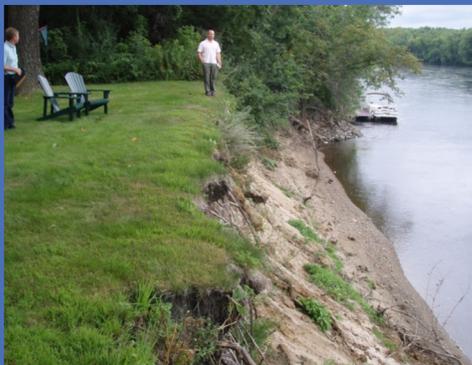
Pre-stabilization conditions consisted of a severe, actively eroding cutbank along 100 ft. of the landowner's shoreline. Bare soil and exposed tree roots were clearly visible.
