# Excerpt from the 2014 Anoka Water Almanac

Chapter 4: Lower Rum River Watershed

Prepared by the Anoka Conservation District

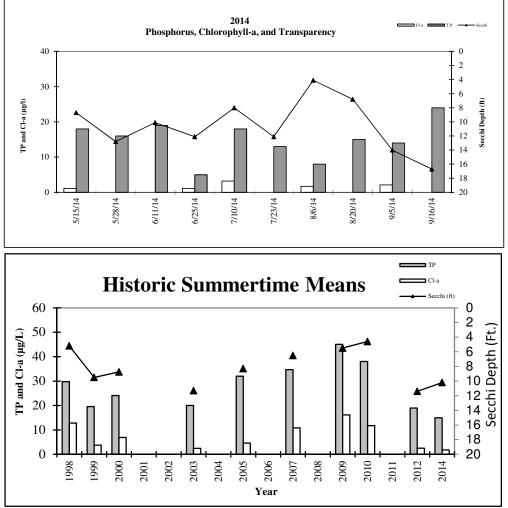
#### **Round Lake Water Quality Results**

In 2014 Round Lake's water quality was very good compared with other lakes in this region (NCHF Ecoregion) receiving an overall A letter grade. The average of total phosphorus (15.0 ug/L) and chlorophyll *a* (1.8 ug/L) were the lowest on record. Secchi transparency was 10.2 feet, which is the second best ever observed. It's important to note that the true Secchi transparency average was deeper than 10.2 feet, one reading was not used in this average since clarity exceeded the maximum depth of the lake.

Phosphorus and algae were fairly consistent without indication of any seasonal fluctuation. Additionally, results were very low. This could be the product of abnormally high rainfall early in the season, which resulted in higher than average lake water levels throughout the entire season.

Ten years of water quality monitoring have been conducted by the Anoka Conservation District (1998-2000, 2003, 2005, 2007, and 2009-2010, 2012, 2014), which is a marginal number of years for a powerful statistical test of trend analysis. In 2010, the results of the analysis indicated a significant trend of declining water quality across the years studied (repeated measures MANOVA with response variables TP, Cl-a, and Secchi depth,  $F_{2,5} = 9.6065$ , p = 0.0194). When the analysis is run to include the exceptional water quality observed in 2012 and 2014 no significant water quality changes are apparent ( $F_{2,7} = 0.41$ , p = 0.68).

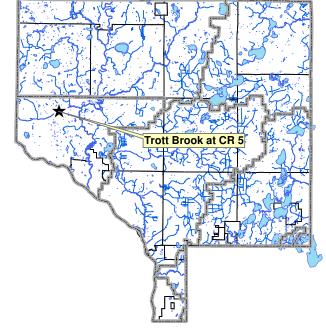
- <u>Dissolved constituents</u>, as measured by conductivity, in Trott Brook was similar to other Anoka County streams. Conductivity averaged 0.482 mS/cm Maximum of 0.595 mS/cm and a minimum of 0.320 mS/cm).

- <u>Phosphorous</u> averaged higher the proposed MPCA water quality standard of 100 ug/l. If the proposed standard is approved Trott Brook often exceeds the limit, even during baseflow periods. Phosphorous in Trott Brook averaged 111 ug/l (maximum of 150 ug/l and a minimum of 78 ug/l).

- <u>Turbidity</u> stayed below the state standards each sampling event. Turbidity averaged 4.2 NTU (maximum of 10.2 NTU and a minimum of 0.00 NTU).
- <u>pH</u> was within the range considered normal and healthy for streams in this area. pH averaged 7.61 (maximum of 7.88 and a minimum of 7.35).

- <u>Dissolved oxygen</u> was periodically below the state water quality standard of 5 mg/L of dissolved oxygen (DO). Low DO in this creek was a known concern based on past monitoring. In 2014 Trott Brook 1 of the 6 DO measurements was below 5 mg/L and all measurements averaged 5.29 mg/l (maximum of 6.38 mg/l and a minimum of 3.69 mg/l). Measurements were not taken in early morning when DO is typically lowest.

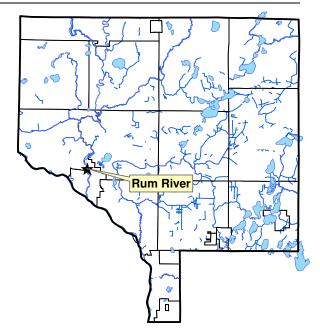
The Rum River originates from Lake Mille Lacs, and flows south through western Anoka County where it joins the Mississippi River in the City of Anoka. In Anoka County the river has both rocky riffles (northern part of county) as well as pools and runs with sandy bottoms. The river's condition is generally regarded as excellent. Most of the Rum River in Anoka County has a state "scenic and recreational" designation. The sampling site is near the Bunker Lake Boulevard bridge behind Anoka High School. Most sampling has been conducted in a backwater rather than the main channel.

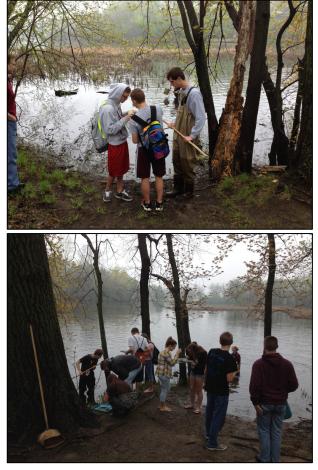
Both chemical and biological monitoring indicate the good quality of this river. Habitat is ideal for a variety of stream life, and includes a variety of substrates, plenty of woody snags, riffles, and pools. Water chemistry monitoring done at various locations on the Rum River throughout Anoka County found that water quality is also good. Both habitat and water quality decline, but are still good, in the downstream reaches of the Rum River where development is more intense and the Anoka Dam creates a slow moving pool.

Historically, biomonitoring near Anoka was conducted mostly in a backwater area that has a mucky bottom and does not receive good flow. This area is unlikely to be occupied by families which are pollution intolerant. In recent years more sampling occurred in the main channel which has more diverse habitat. This change in sampling explains the apparent improvement in the invertebrate community in recent years. In 2014 sampling returned to the backwater area, however extreme water levels likely altered its normal functions.

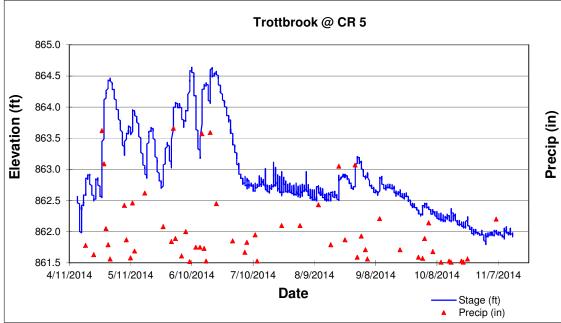
#### 2014 Hydrograph

Trott Brook is a medium-sized creek that flows south through Sherburne County, paralleling the Anoka-Sherburne County boundary before turning east through the City of Ramsey where outlets to the Rum River. Overall, the watershed is rural or suburban residential, and areas within the watershed are undergoing rapid development. The creek is about 25 feet wide and 2.5 feet deep at the monitoring site during baseflow.

A rating curve for this site was developed in 2013:

Flow (cfs) =  $16.39(\text{stage-859})^2 - 63.716(\text{stage-859}) + 65.908$

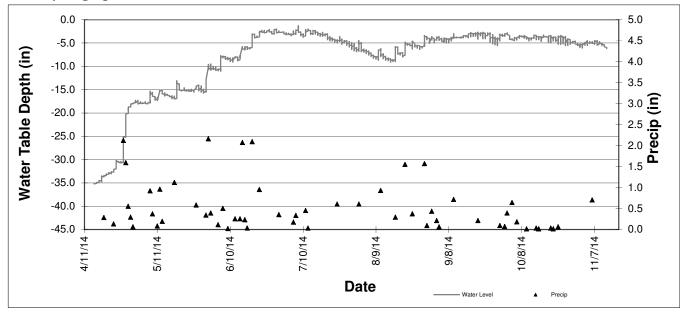
#### 2014 Hydrograph

Well is located at the wetland boundary.

Well depth was 42 inches, so a reading of -42 indicates water levels were at an unknown depth greater than or equal to 42 inches.

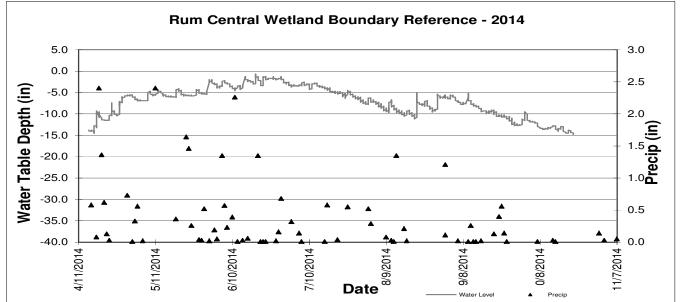
Well depth was 40 inches, so a reading of -40 indicates water levels were at an unknown depth greater than or equal to 40 inches.

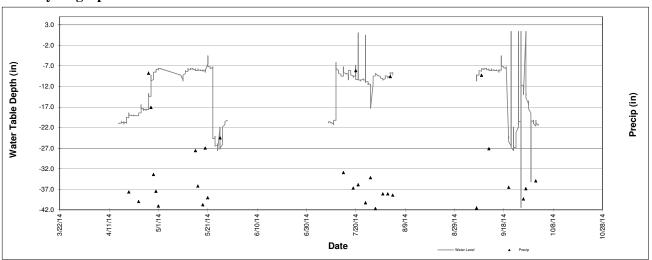
#### 2014 Hydrograph

Well is located about 10 feet east and about 6 inches downslope of the wetland boundary. DNR Public Water Wetland 2-339.

Well depth was 40 inches, so a reading of -40 indicates water levels were at an unknown depth greater than or equal to 40 inches. Equipment deployed at this site experienced a multitude of malfunctions. Data should be interpreted accordingly.
