Excerpt from the 2016 Anoka Water Almanac

Chapter 4: Lower Rum River Watershed

CHAPTER 4: LOWER RUM RIVER WATERSHED

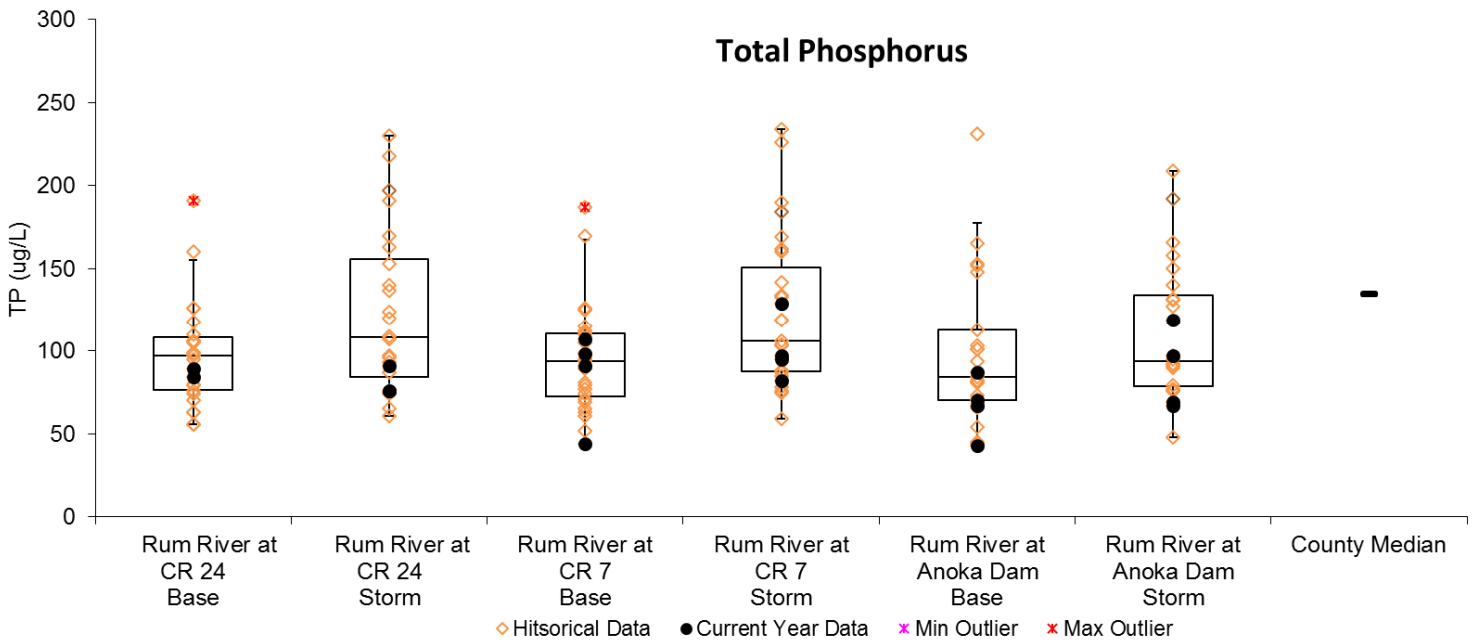
Total phosphorus during baseflow and storm conditions Orange diamonds are historical data from previous years and black circles are 2016 readings. Box plots show the median (middle line), 25th and 75th percentile (ends of box), and 10th and 90th percentiles (floating outer lines).

Total phosphorus in the Rum River is acceptably low and is lower than the median for all other monitored 34 Anoka County streams (see figure below). 2016 readings averaged lower than 2015 results, which had a marked decrease from 2014 results. This nutrient is one of the most common pollutants in our region, and can be associated with urban runoff, agricultural runoff, wastewater, and many other sources. The median phosphorus concentration in 2016 at the three monitored sites (all conditions) was 84, 96 and 87 ug/L. These upstream-to-downstream differences are negligible and there is no trend of increasing phosphorus downstream. All sites in 2016 had phosphorus concentrations lower than the median for Anoka County streams of 135 ug/L. In 2015 the highest observed total phosphorus reading was during one particular storm event, with a maximum of 132. In all, phosphorus in the Rum River is below the state standard of 100 ug/L, but should continue to be an area of pollution control effort as the area continues to be developed.

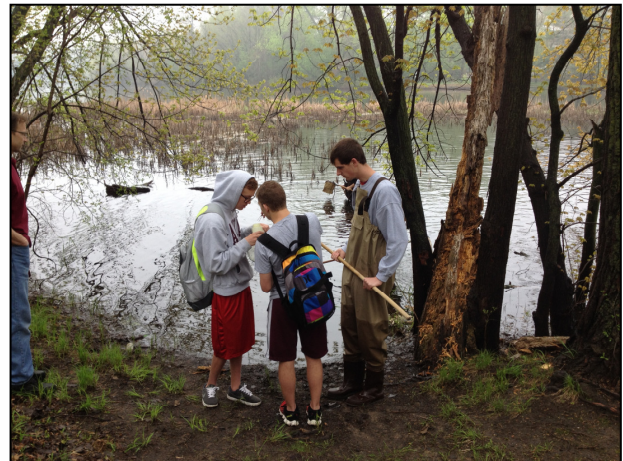
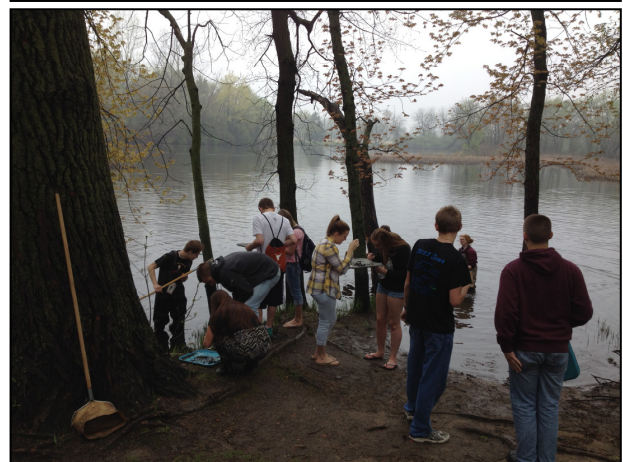
Both chemical and biological monitoring indicate the good quality of this river. Habitat is ideal for a variety of stream life, and includes a variety of substrates, plenty of woody snags, riffles, and pools. Water chemistry monitoring done at various locations on the Rum River throughout Anoka County found that water quality is also good. Both habitat and water quality decline, but are still good, in the downstream reaches of the Rum River where development is more intense and the Anoka Dam creates a slow moving pool.

Historically, biomonitoring near Anoka was conducted mostly in a backwater area that during periods of low water level has a mucky bottom and does not receive good flow. During those conditions the area was unlikely to be occupied by families which are pollution intolerant. Recent monitoring has included sampling the main channel during an extremely low water level condition, followed by multiple years of very high water levels. The main channel and higher water levels offer opportunities for a more diverse habitat. These changes in sampling likely explain the apparent improvement in the invertebrate community in recent years.

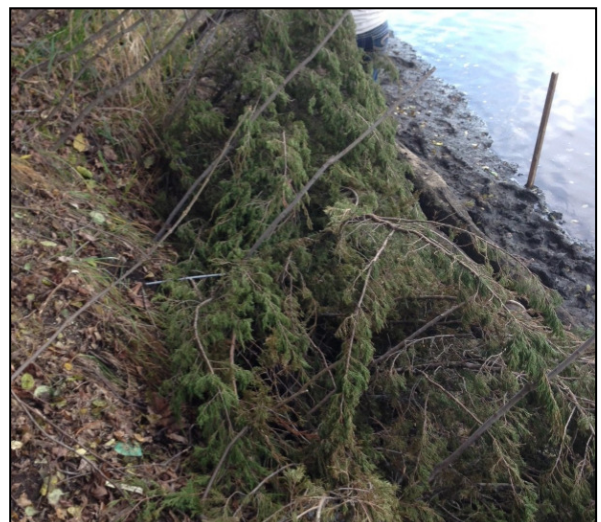
2016 funded project – Brauer Rum Riverbank, City of Ramsey

Approximately 90 feet of undercut, eroding riverbank was stabilized using a cedar tree revetment. This project was funded with direct landowner contributions, LRRWMO cost share dollars, as well as a Conservation Corps of MN crew labor grant. Installation was done by the Minnesota Conservation Corps with oversight from the Anoka Conservation District in the fall of 2016.

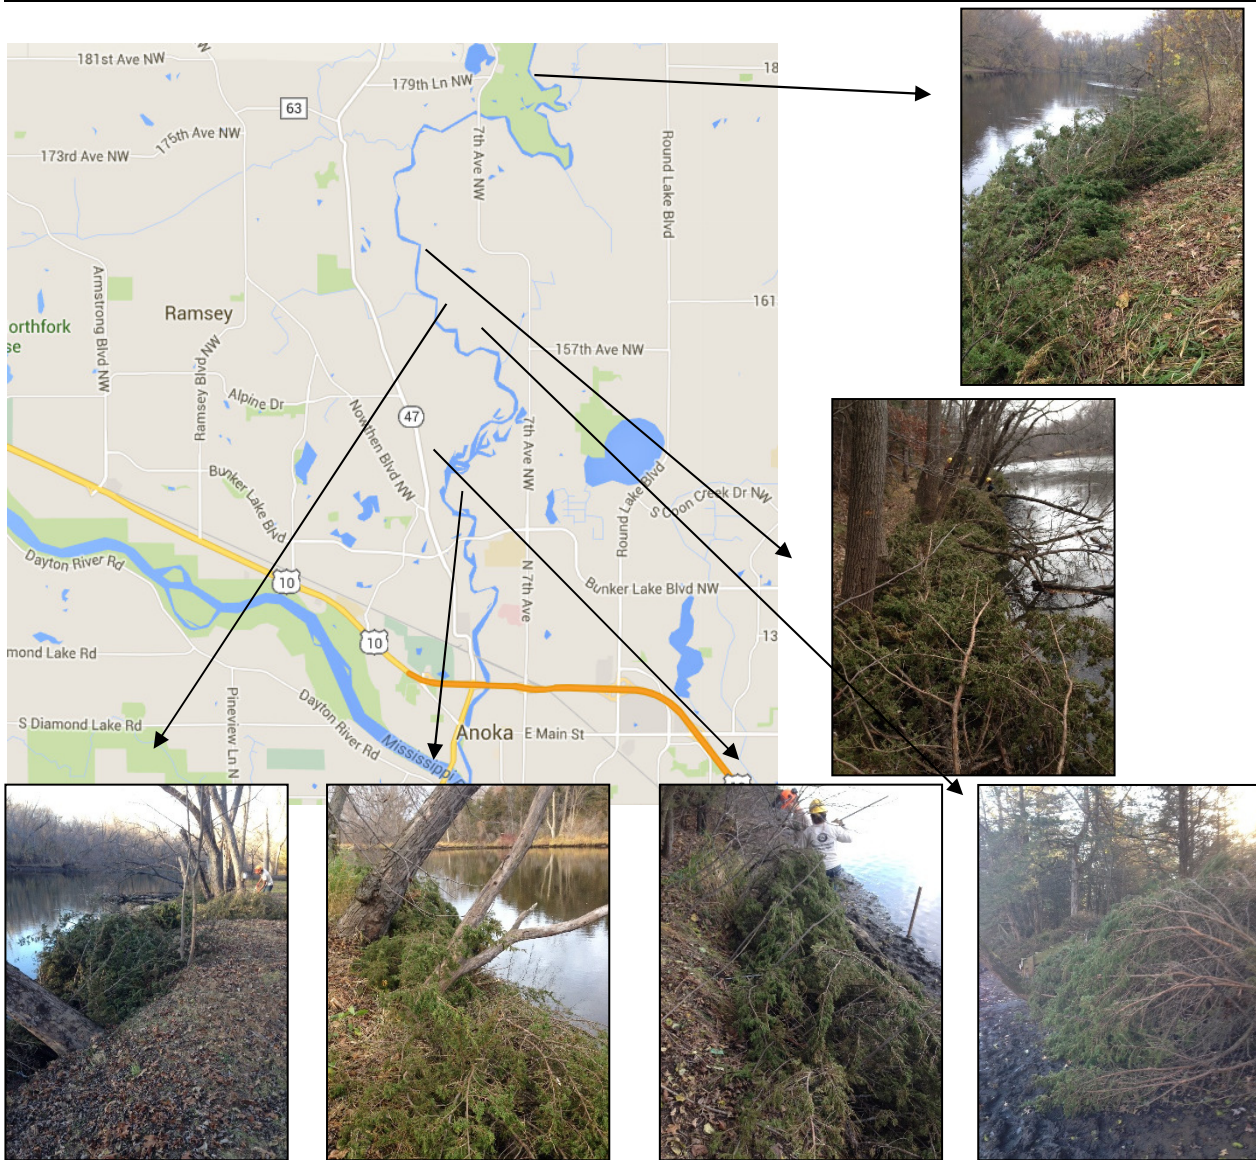
Purpose: To stabilize areas of riverbank with mild to moderate erosion, in order to reduce sediment loading in the Rum River, as well as to reduce the likelihood of a much larger and more expensive corrective project in the future.

Results: Stabilized 1,316 linear feet of riverbank on the Rum River.

Cedar tree revetments are a low cost, but effective, means to address minor bank erosion before it gets worse. It's not appropriate for major bank erosion, such as on outside bends of the river. The technique involves cable-anchoring cut cedar trees alongside the bank. Their dense branches and naturally rot-resistant wood provide many years of bank armoring. In doing so, they protect property, help improve the river's water quality and provide fish habitat.
